ANALYSIS AND RECOVERY OF A COMPRESSED AIR RESERVOIR: PNEUMATIC AUTOMATION WORKBENCH

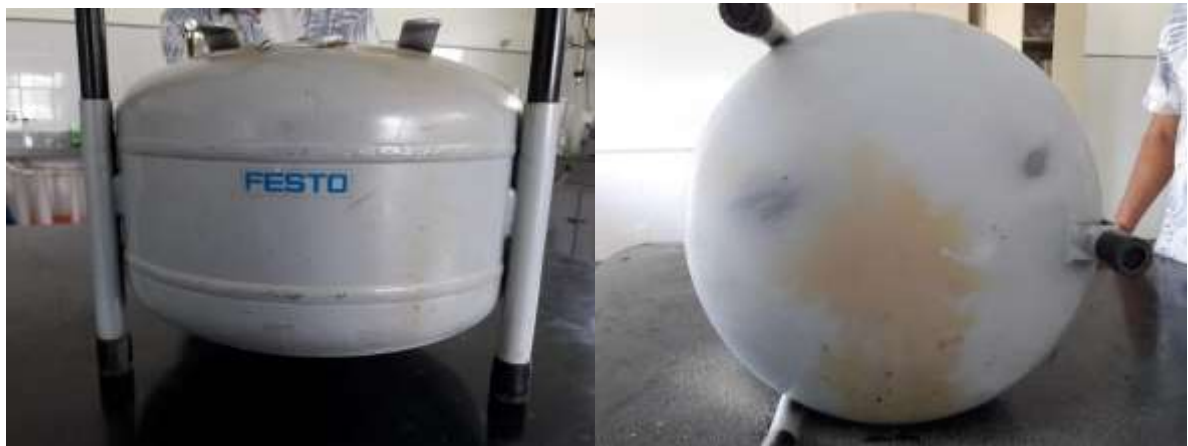
Figure 1 - Compressed air reservoir

The air reservoir used in this study was the pneumatic automation workbench located at the Federal Institute of Education, Science and Technology of Espírito Santo - IFES (Sao Mateus, Brazil), which presented defects that prevented its use, did not maintain the pressure to which it was submitted. Figure 1 illustrates this reservoir.

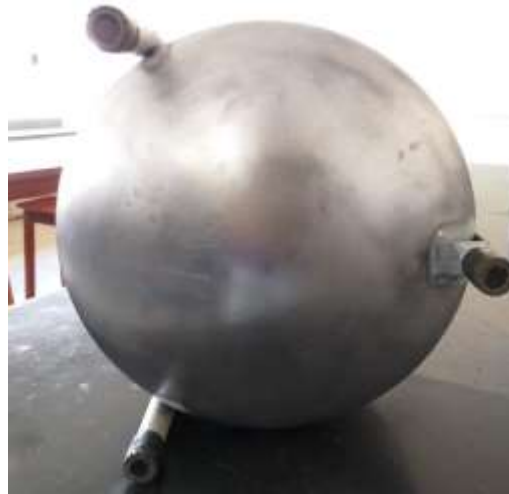
Figure 2 - Reservoir after bottom sanding

The first step of the work was to perform the VT. By attempting to use the equipment, it was found that the defect was in the lower part of the reservoir, showing leakage. To remove the paint layer from the equipment, the analyzed region was sanded with silicon carbide sandpaper (80, 100, 200, 400 mesh size). Two forms of sanding were performed, manually and with the aid of an automatic sander. After removal of the paint layer, no visually perceptible defects were identified. Figure 2 illustrates the bottom of the reservoir after this design step.

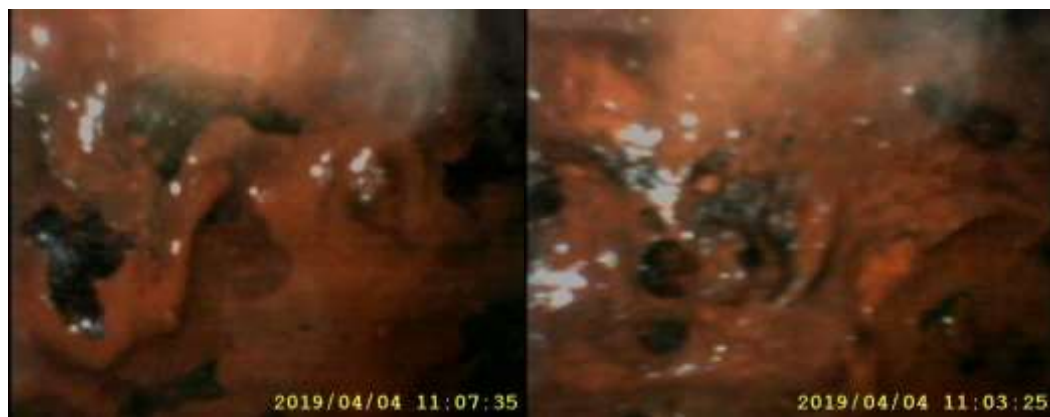
Figure 5 - Images obtained by the endoscope

According to the images obtained, Figure 5, it was observed the presence of incrustations present inside the reservoir, especially in the lower part, where visual inspection was performed. These fouling were possibly caused by the accumulation of contaminant residues that entered the system, such as dirt, lubricants and water.

When performing the reservoir recovery process, discontinuities were detected by the ultrasonic testing, previously identified with LPI, which was some localized points of corrosion, characterized by its geometry as pitting corrosion. This defect may have occurred due to the presence of scale (formed by water and impurities) that were located at the bottom of the reservoir, as shown by the endoscope.

As the reservoir worked at room temperature and without aggressive fluid, it was evaluated that the deterioration of the reservoir was due to the formation of electrochemical corrosion. As improvement measures for the equipment, preventive maintenance may be performed on the bench, especially in the filtration and trap areas to prevent contaminants from entering and effective output if needed, performing ultrasonic inspections to check for changes in the thickness of the reservoir.

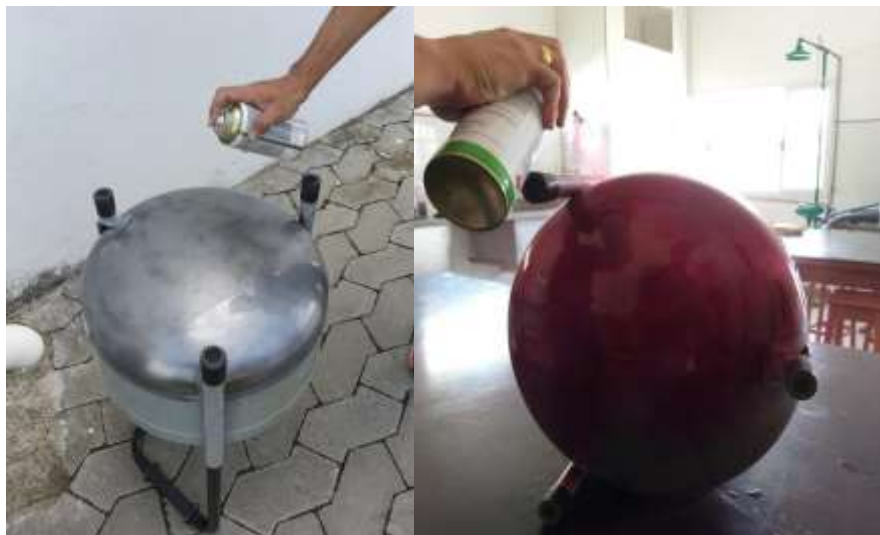
Figure 7 - Application of the remover and liquid penetrant, respectively

The liquid penetrate inspection (LPI), Type II - Technique A, was performed according to Abendi PR-001 standard. First, the surface was cleaned with a wire brush, then according to Figures 6 and 7, the E-59 remover was used to remove any substance still on the surface. With the surface clean and dry, LP SKL-WP was applied leaving the surface resting for 30 minutes as recommended by the manufacturer. After standing time, the test surface was washed with running water, dried and the developer SKD-S2 applied.

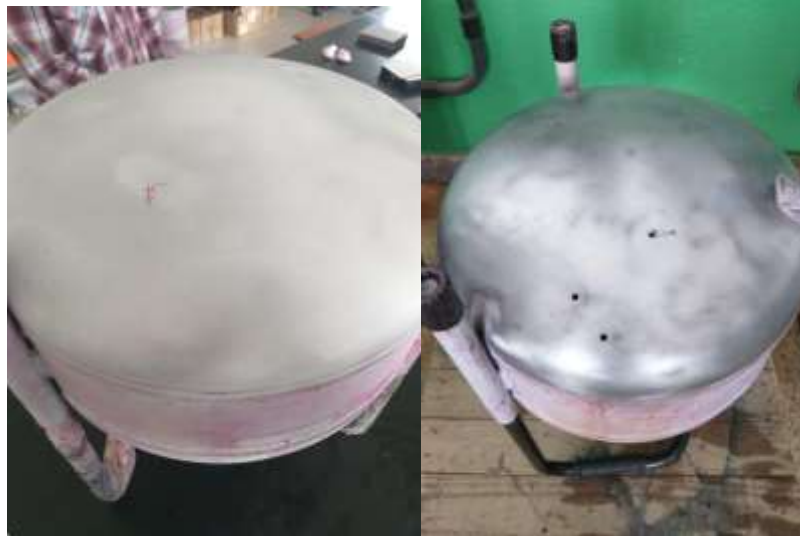
Figure 8 - Reservoir bottom after developer application and drilling

After a few minutes of developer application, Figure 8, holes were detected. These were marked and drilled with the aid of a drill.

Then, the reservoir was sent to the welding laboratory of the Federal Institute of Education, Science and Technology of Espírito Santo - IFES (Sao Mateus, Brazil), in which the holes were filled with filler metal filler. The welding process used was the MAG (Metal Active Gas), Figure 9, applying as parameters a voltage of 19.6 V, a speed of 82 IPM and a copper-coated steel electrode.

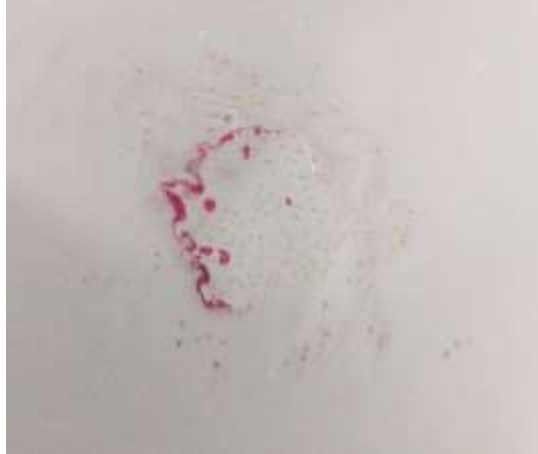
Figure 10 - Revelation in the weld region through the LPI

Again, the reservoir has returned to the sanding step to improve surface finish. Then, the LPI was performed again so that it could analyze the quality of the solder performed. As shown in Figure 10, the assay revealed some pores in the filler regions of the weld. These pores must

have been caused by insufficient gas addition at the time of welding, causing the filler metal to react with ambient air.

Due to the formation of these pores, the reservoir returned to the drilling and welding steps again. After undergoing the LPI and UT, the recovery process was continued, finally performing another cleaning and then painting the reservoir, finished as shown in Figure 11.
